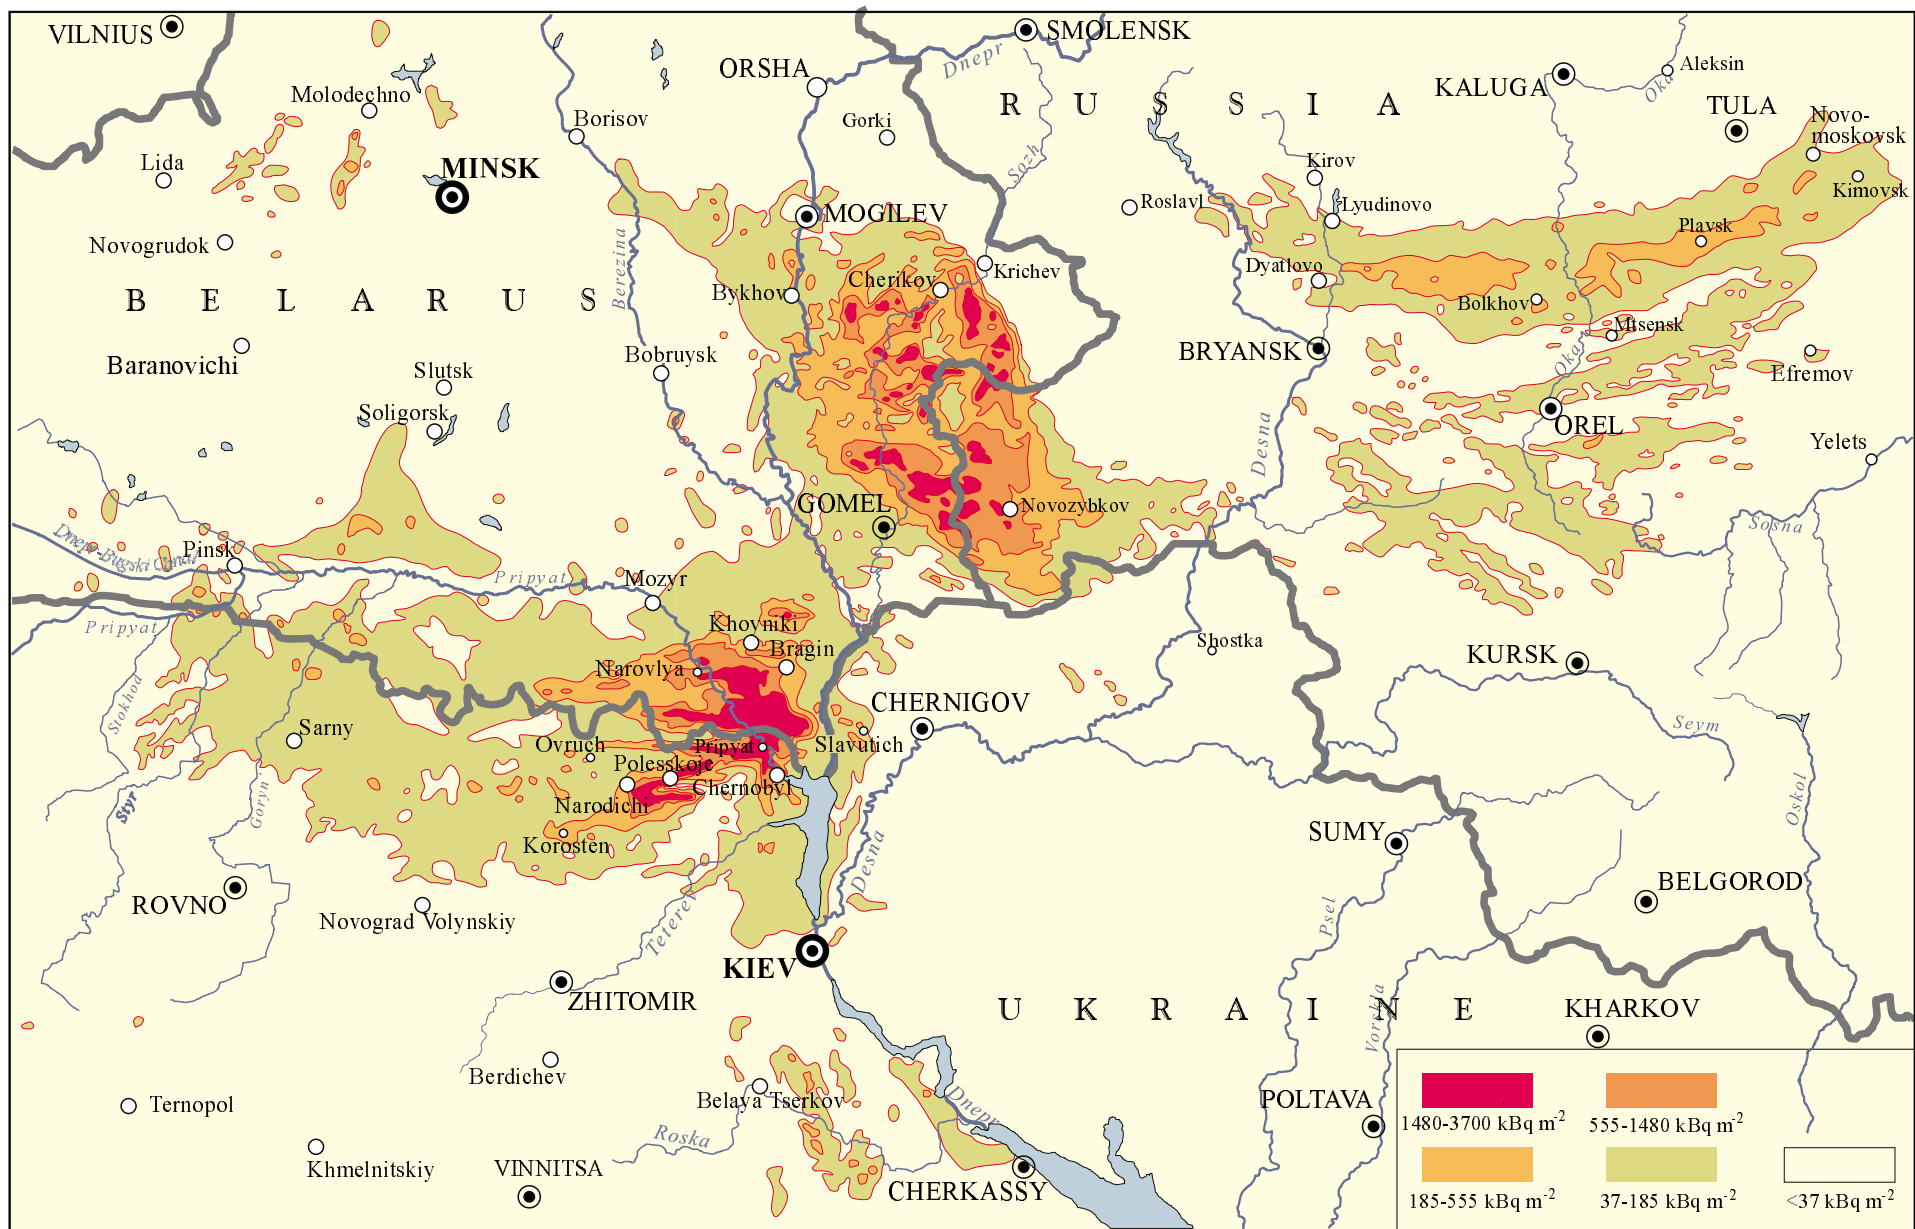
Figure VI. Surface ground deposition of caesium-137 released in the Chernobyl accident [11, 13].
